| No: | SB140-13 | Issue: | 001 |

SUBJECT: Volvo Engine E5, Re-position Wiring Loom.

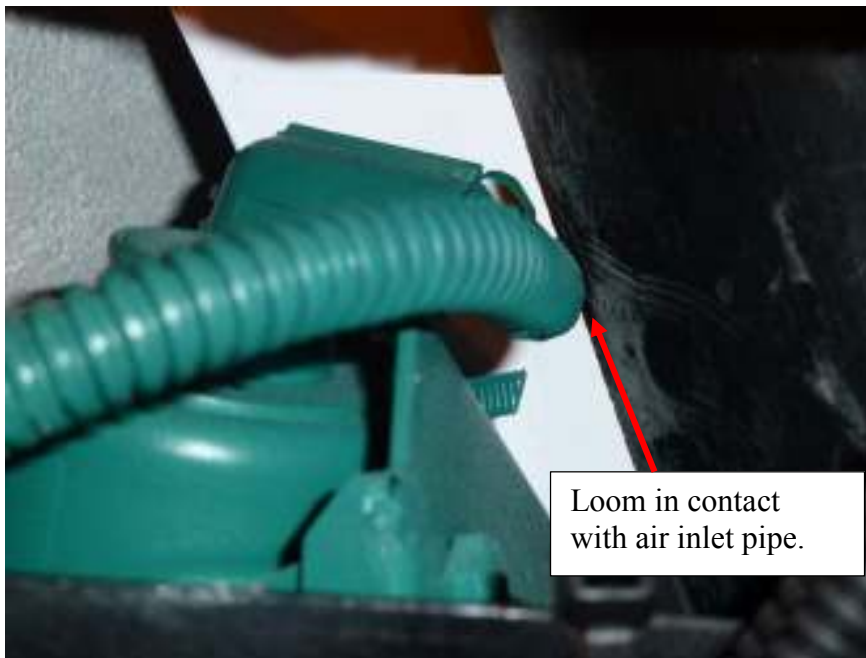
It has been reported that some vehicles have been delivered with a wiring loom incorrectly installed making it possible for the loom to be in contact with the air inlet pipe.
