No:	SB 152-15	Issue:	1
Date:	11/12/2015	Sheet:	Page 1 of 2

SUBJECT: Elite 2 Cab Beacon Ground Connection Improvement

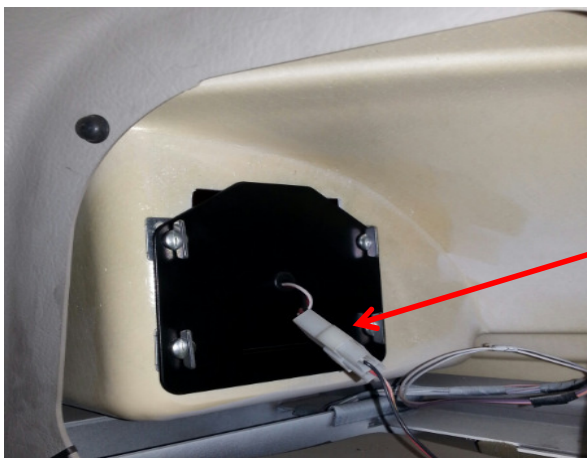
Two pin plug

2. Remove the two pin plug as in Fig 2. connecting the beacon motor to the cab roof loom and remove the motor assembly.

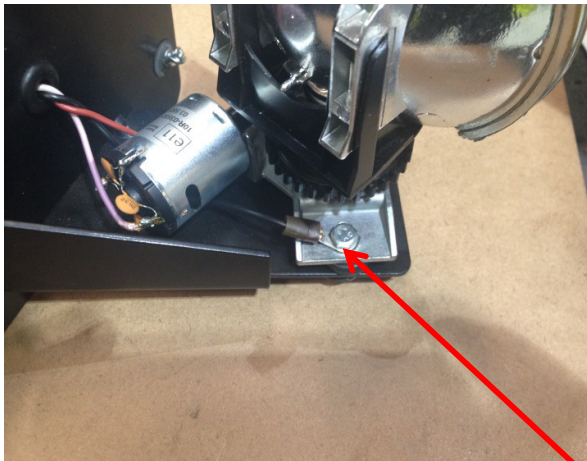
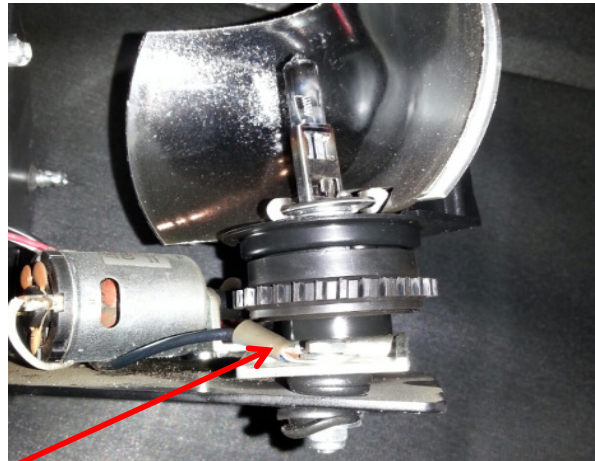
3. If the ground ring terminal is mounted to the beacon motor as shown in Fig 3 & 4. below re-position as shown in instruction number 4.

This ground terminal is bolted to the rubber mount point, it can lead to a poor ground connection as the beacon flexes/vibrates.

4. Re-position the terminal to the point shown in Fig 5. below using a short self-tapping screw to ensure the screw does not foul on the beacon mounting bracket.

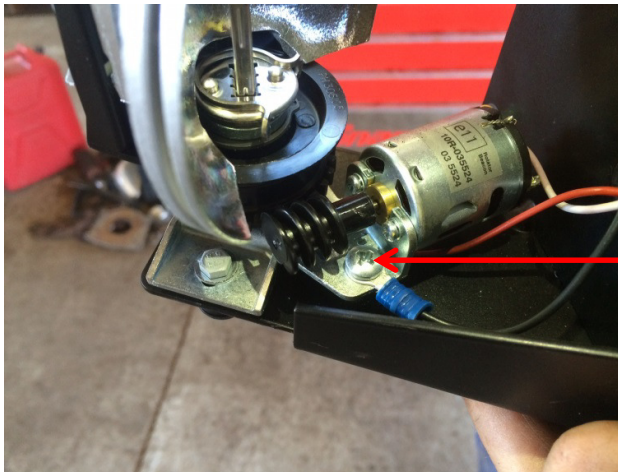
Fig 5.

New ground point on beacon motor
