SB174-17

Elite 6 6x4 Rubber Suspension Settling In Phase Reference Re-Calibration

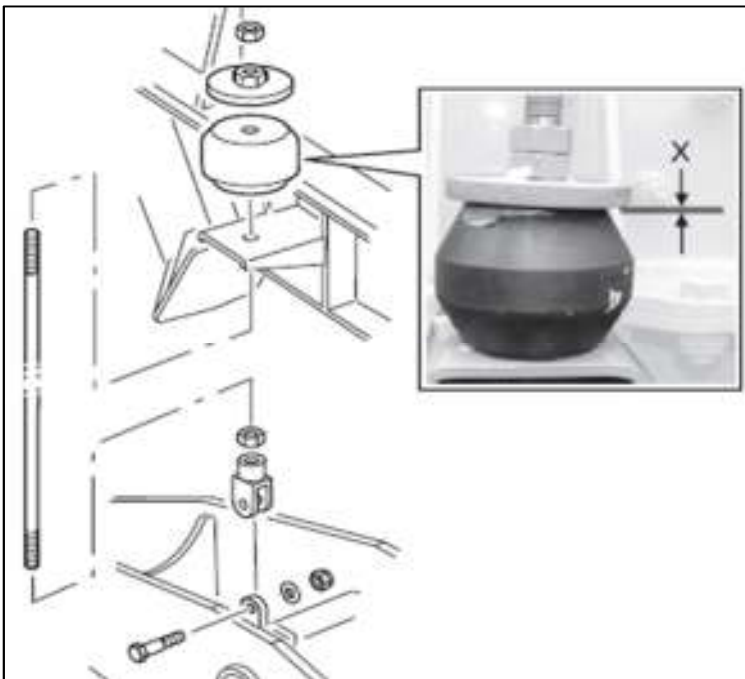
Fig 1

Within the first few weeks of service the Hendrickson Rubber Suspension will go through a settling in phase. This can be seen by a gap in the balance bar tie rod and rubber mount forming "X" see fig 1. The gap should be between 0-0.25mm

The instrument cluster may show you an air bag warning light with a fault code of SPN 521121 FMI 15 when the vehicle is loaded. This fault code indicates excessive load on axle 2 equating to the rear bogie.

If you have an Elite 6 with Hendrickson Rubber Suspension, it is recommended that you contact your local service centre after 3 weeks to have this recalibrated.
