NO.:	SB133-12	ISSUE NO.:	1
DATE:	06/02/12	SHEET:	1 of 1

SUBJECT: Elite Footbrake Pedal Sticking

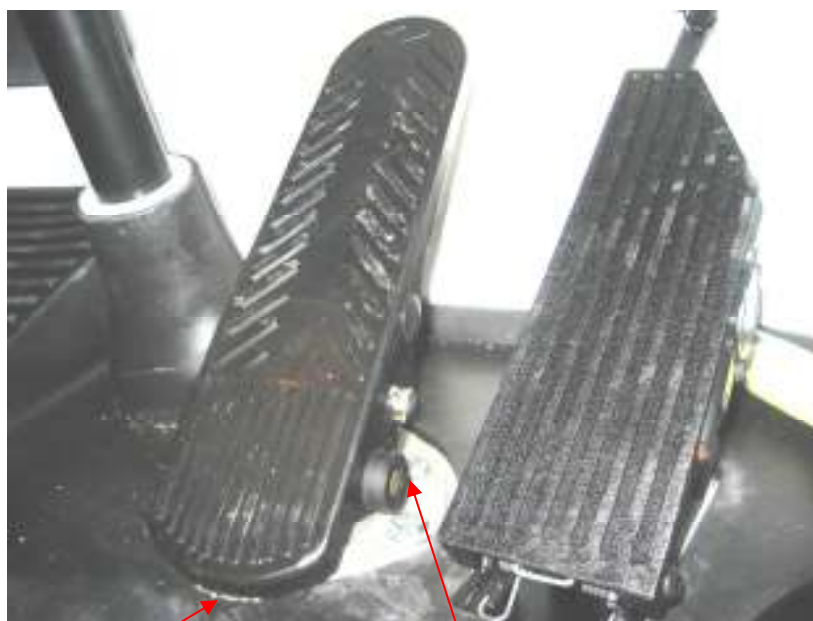
Check for debris
under the heel of
Brake Pedal

Lubricate Brake
Pedal Pivot Pin

On investigation by Dennis Eagle and Knorr Bremse the problem has been traced back to the foot brake pedal sticking either through lack of lubrication, which has caused the pivot pin to corrode, or debris under the heel of the foot brake pedal.

To alleviate the problem of the corrosion on the brake pedal pivot pin a stainless steel pivot pin has been introduced on current production vehicles.

For vehicles currently in service a Service Kit (SL1043) is available from the Parts Department at Dennis Eagle Tel No. 01926458555
