No:	SB143-13	Issue:	1
Date:	29/07/13	Sheet:	Page 1 of 2

**SUBJECT:** Sweep Plate Pin Grub Screw (MCG-3110-10S)

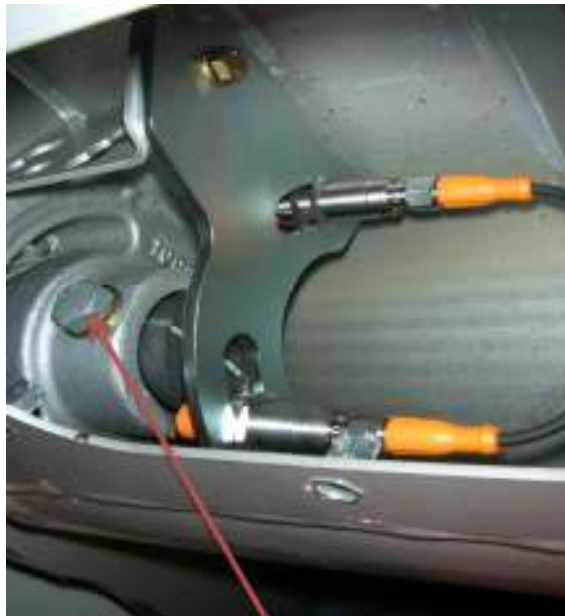
Remove locating bolt. Taking care not to disturb the proximity switches on the L/H side.

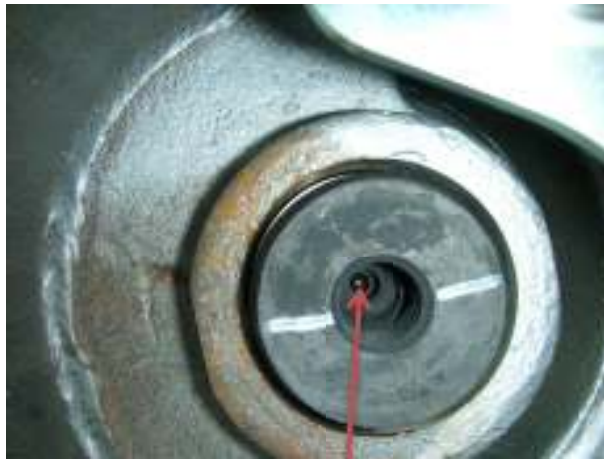
Using an Alan key fit the grub screw to the inner tapped hole

Repeat the process on the R/H side and refit cover plates. Remove grease point covers on the outside of the hopper and grease the pins.
