No:	SB163-16	Issue:	1
Date:	10/10/2016	Sheet:	Page 1 of 1

SUBJECT: EBS Warning Lamps on Elite 6 Vehicles

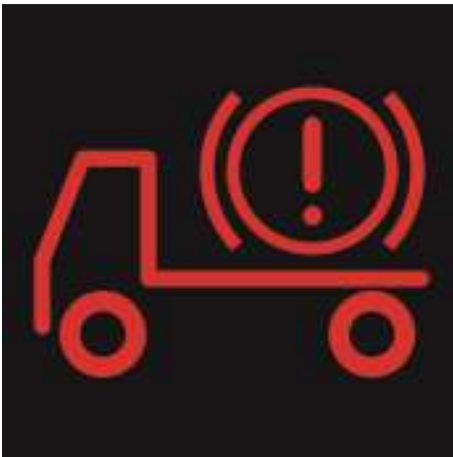
Fig.1

There are two warnings that appear when the ignition is switched on; one is a pictogram below the Dennis Eagle logo on the instrument cluster (Fig.1 or Fig.2), the other is a lamp on the bottom of the instrument cluster (fig.3). Both will extinguish after a system check providing there is no system malfunction.
