No: SB168-17

Subject: Olympus Rear Body Chute Security (Optional Extra)

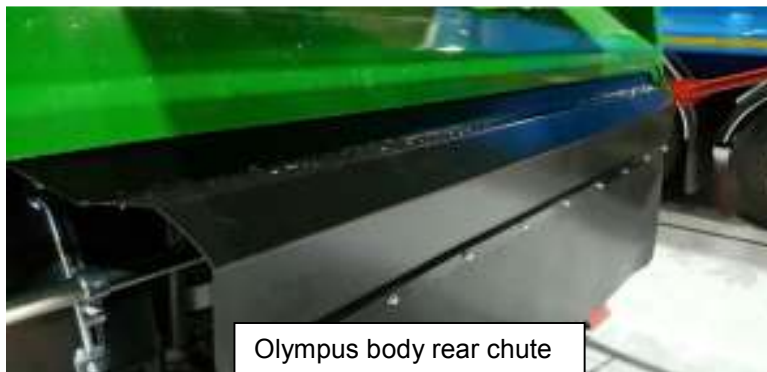
Dennis Eagle have received a small number of reports of the rear body chutes mounted on the Olympus bodies coming loose due to the nut inserts pulling through the rear body cross member.

Olympus body rear chute

As a precautionary measure Dennis Eagle need customers to inspect and check the security of the chute and include this check on all future six weekly inspections. If you find your chute has come loose please remove it from the body and report it to your local service centre along with vehicle identification details. Dennis Eagle will then make arrangements to come and refit the chute.

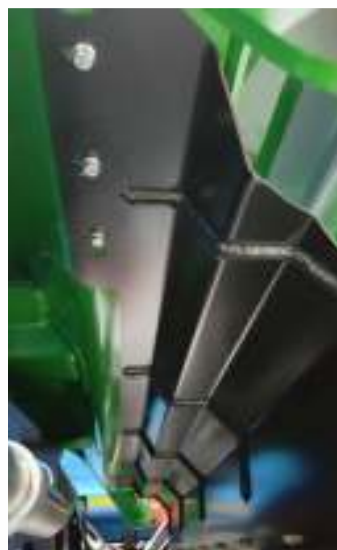
8 x fixings into rear cross member
